**Flood Control Project Maintenance
Levee Inspections**

Maintenance Issue Types Only, Levee Inspection Report By Mile - Spring 2017

Sacramento Maintenance Yard West Levee Yolo Bypass

Waterway	Bank	Unit Miles	Inspection Start/End	Inspector
Unit No. 01 West Levee	Right	2.73	04/05/2017 04/05/2017	Zach Jojola

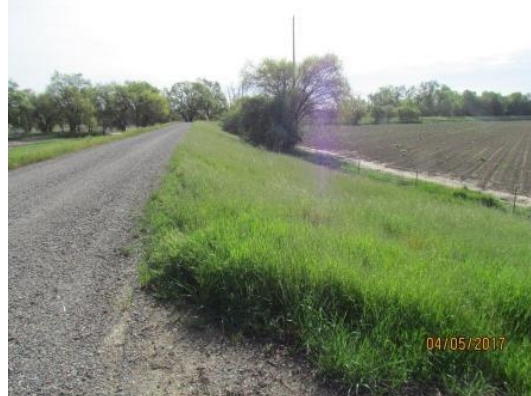
Photo 1 of 1 : SP_2017_ST0011_291_14_20170413_00021.jpg

LM Start	0.00	Rating **	U	Issue No.	14
LM End	2.72	Issue Type +	Ma	Location *	LS
Category	Earthen Levee			GPS Latitude/Longitude	
				Start	End
Item	Vegetation			38.758935 °	38.724274 °
				-121.667521 °	-121.665112 °
DWR ID	DWR_ST0011_01_s_2017_14				
Comment Code					
V1 : Control annual grass and weeds on the levee slopes and easements.					
Inspector Comment

Tall grass on landside levee slope, blocking visibility. Spring 2017.

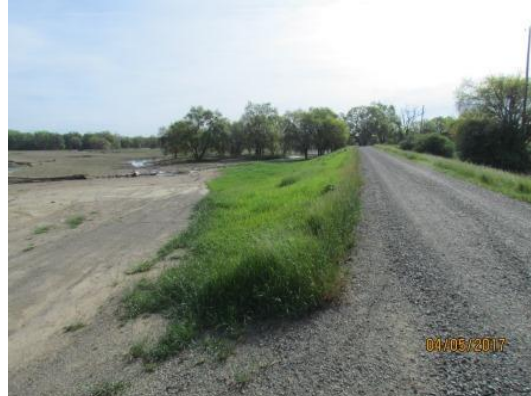
Photo 1 of 1 : SP_2017_ST0011_291_13_20170413_00020.jpg

LM Start	0.00	Rating **	U	Issue No.	13
LM End	2.72	Issue Type +	Ma	Location *	WS
Category	Earthen Levee			GPS Latitude/Longitude	
				Start	End
Item	Vegetation			38.758933 °	38.724274 °
				-121.667519 °	-121.665112 °
DWR ID	DWR_ST0011_01_s_2017_13				
Comment Code					
V1 : Control annual grass and weeds on the levee slopes and easements.					
Inspector Comment

Tall grass on waterside levee slope, blocking visibility. Spring 2017.

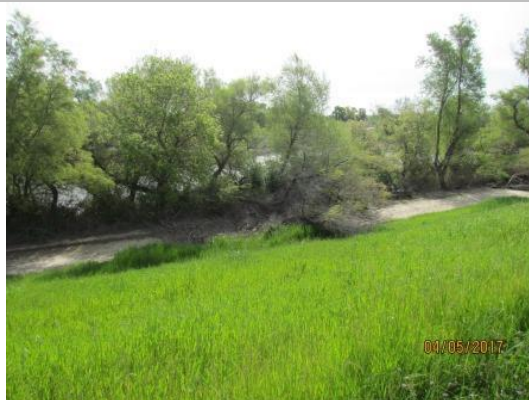
Photo 1 of 1 : SP_2017_ST0011_291_15_20170413_00022.jpg

LM Start	2.18	Rating **	M	Issue No.	15
LM End	2.18	Issue Type +	Ma	Location *	WS
Category	Earthen Levee			GPS Latitude/Longitude	
				Start	End
Item	Encroachments			38.729822 °	38.729822 °
				-121.660268 °	-121.660268 °
DWR ID	DWR_ST0011_01_s _ 2017_15				
Comment Code					
TR : Tree or limb					
Inspector Comment					
Fallen tree on waterside levee toe.

View of fallen tree at waterside levee toe, looking downstream. Spring 2017.

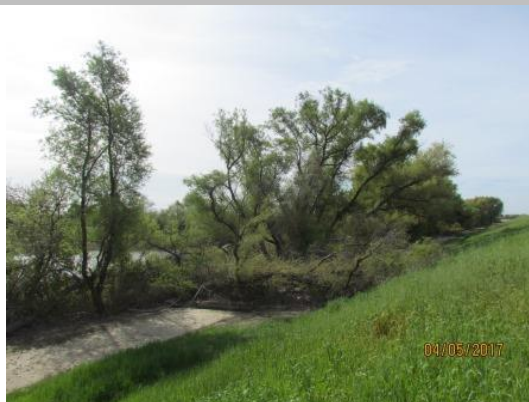
Photo 1 of 1 : SP_2017_ST0011_291_16_20170413_00023.jpg

LM Start	2.20	Rating **	M	Issue No.	16
LM End	2.20	Issue Type +	Ma	Location *	WS
Category	Earthen Levee			GPS Latitude/Longitude	
				Start	End
Item	Encroachments			38.729588 °	38.729588 °
				-121.660263 °	-121.660263 °
DWR ID	DWR_ST0011_01_s _ 2017_16				
Comment Code					
TR : Tree or limb					
Inspector Comment					
Fallen tree on waterside levee toe and slope.

View of fallen tree on waterside levee slope, looking downstream. Spring 2017.

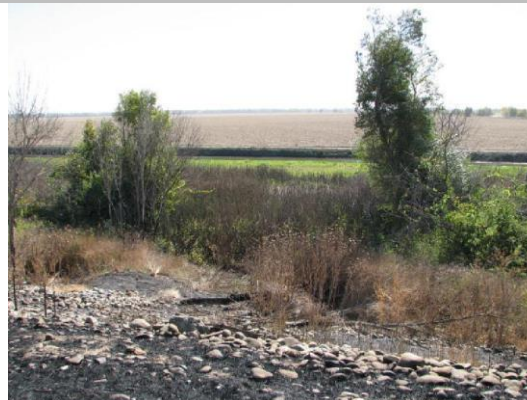
Photo 1 of 3 : UCIP_SP_2017_50787_60304.jpg

LM Start	2.63	Rating **	A/W	Issue No.	18
LM End	2.63	Issue Type +	Ma	Location *	WS
Category	Supplemental			GPS Latitude/Longitude	
				Start	End
Item	DWR UCIP LMA Responsibility			38.724824 °	38.724824 °
				-121.663702 °	-121.663702 °
DWR ID					
Comment Code					
Inspector Comment					
FS_ID:50787					
DS_ID:17742					
EP_NO: 10284					
Repair Type: No Action Needed					
Crossing Status: Found					
UCIP Comments: Screw gates where removed and pipe was abandoned by farmer, How pipe was abandoned is unknown.					
FIELD_STRUCT_DESC: One of two pipes.Two 42-inch CM drainpipes through levee 23.6 feet below crown. Concrete spill box at toe of landward slope. (ABO No. 10284 - Hershey).					
O&M manual 127, Revision Year 2011					
FS Date: 11/18/2016 2:57:05 PM

Waterside view: overview (pipe not found)

FS_ID:50787
DS_ID:17742
EP_NO: 10284
Repair Type: No Action Needed
Crossing Status: Found
UCIP Comments: Screw gates were removed and pipe was abandoned by farmer, How pipe was abandoned is unknown.
FIELD_STRUCT_DESC: One of two pipes. Two 42-inch CM drainpipes through levee 23.6 feet below crown. Concrete spill box at toe of landward slope. (ABO No. 10284 - Hershey).
O&M manual 127, Revision Year 2011
FS Date: 11/18/2016 2:57:05 PM

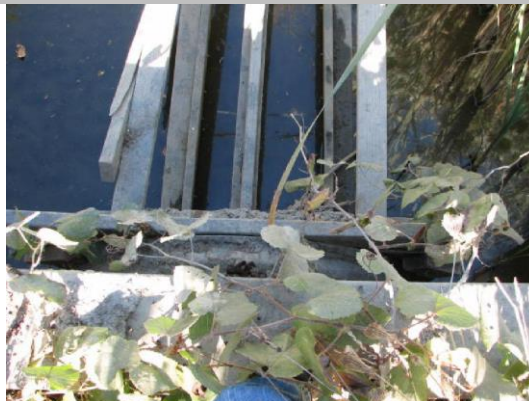
Photo 2 of 3 : UCIP_SP_2017_50787_60303.jpg

Landside view: concrete spillbox/headwall and pipe (top view)

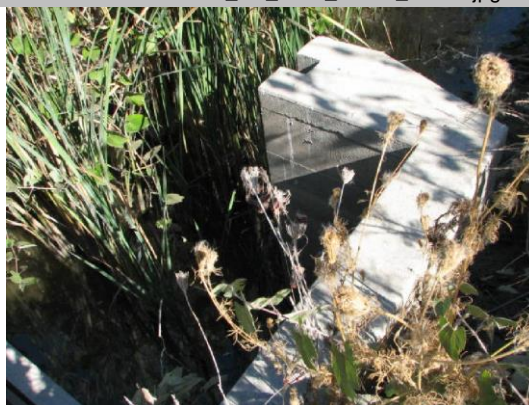
Photo 3 of 3 : UCIP_SP_2017_50787_60302.jpg

Landside view: side of concrete spillbox/headwall

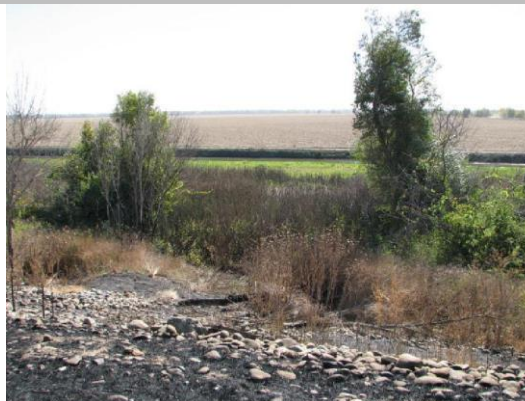
Photo 1 of 3 : UCIP_SP_2017_50788_60309.jpg

LM Start	2.64	Rating **	A/W	Issue No.	19
LM End	2.64	Issue Type +	Ma	Location *	WS
Category	Supplemental			GPS Latitude/Longitude	
				Start	End
Item	DWR UCIP LMA Responsibility			38.724811 °	38.724811 °
				-121.663736 °	-121.663736 °
DWR ID					
Comment Code					
Inspector Comment					
FS_ID:50788					
DS_ID:17747					
EP_NO: 10284					
Repair Type: No Action Needed					
Crossing Status: Found					
UCIP Comments: No slide gate found. slide gates and pipes were abandon by farmer, how unknown					
FIELD_STRUCT_DESC: Two of two pipes. Two 42-inch CM drainpipes through levee 23.6 feet below crown. Concrete spill box at toe of landward slope. (ABO No. 10284 - Hershey).					
O&M manual 127, Revision Year 2011					
FS Date: 11/18/2016 2:57:12 PM

Waterside view: overview

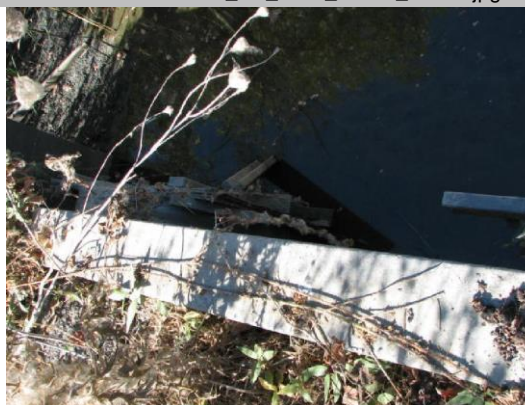
Photo 2 of 3 : UCIP_SP_2017_50788_60308.jpg

Landside view: concrete spill box

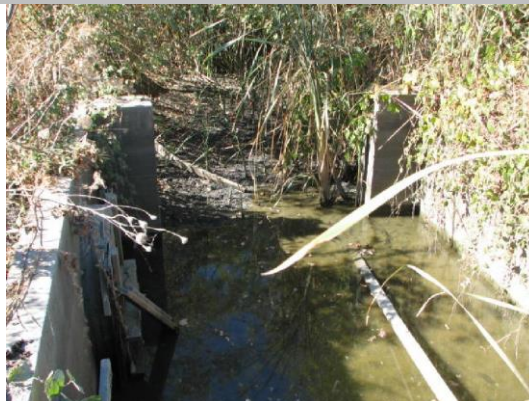
Photo 3 of 3 : UCIP_SP_2017_50788_60307.jpg

Landside view: CM pipe with flap gate

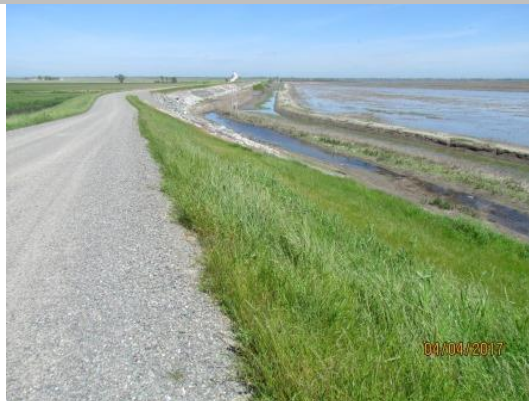
Photo 1 of 1 : SP_2017_ST0011_292_4_20170413_00011.jpg

LM Start	0.01	Rating **	U	Issue No.	4
LM End	1.43	Issue Type +	Ma	Location *	WS
Category	Earthen Levee			GPS Latitude/Longitude	
				Start	End
Item	Vegetation			38.718969 °	38.699879 °
				-121.664111 °	-121.674034 °
DWR ID	DWR_ST0011_02_s_2017_4				
Comment Code					
V1 : Control annual grass and weeds on the levee slopes and easements.					
Inspector Comment

Tall grass on waterside levee slope, blocking visibility. Spring 2017.

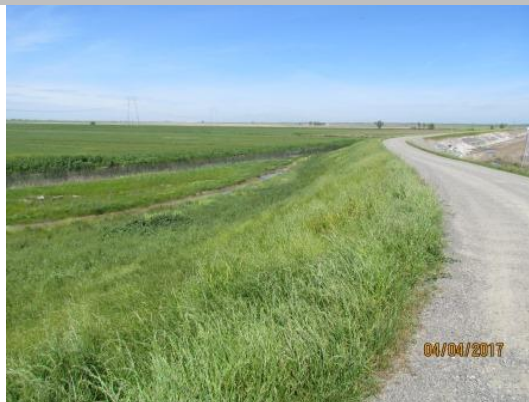
Photo 1 of 1 : SP_2017_ST0011_292_2_20170413_00010.jpg

LM Start	0.01	Rating **	U	Issue No.	2
LM End	1.51	Issue Type +	Ma	Location *	LS
Category	Earthen Levee			GPS Latitude/Longitude	
				Start	End
Item	Vegetation			38.718969 °	38.698683 °
				-121.664111 °	-121.674135 °
DWR ID	DWR_ST0011_02_s_2017_2				
Comment Code					
V1 : Control annual grass and weeds on the levee slopes and easements.					
Inspector Comment

Tall grass on landside levee slope, blocking visibility. Spring 2017.

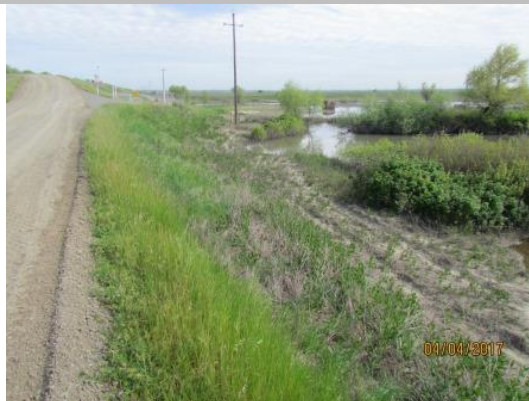
Photo 1 of 1 : SP_2017_ST0011_293_5_20170413_00008.jpg

LM Start	0.01	Rating **	U	Issue No.	5
LM End	0.78	Issue Type +	Ma	Location *	WS
Category	Earthen Levee			GPS Latitude/Longitude	
				Start	End
Item	Vegetation			38.698496°	38.687364°
				-121.674131°	-121.673715°
DWR ID	DWR_ST0011_03_s_2017_5				
Comment Code					
V1 : Control annual grass and weeds on the levee slopes and easements.					
Inspector Comment

Tall grass on waterside levee slope, blocking visibility. Spring 2017.

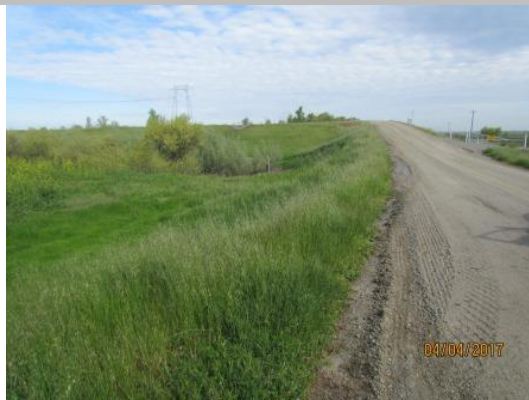
Photo 1 of 1 : SP_2017_ST0011_293_4_20170413_00007.jpg

LM Start	0.01	Rating **	U	Issue No.	4
LM End	0.76	Issue Type +	Ma	Location *	LS
Category	Earthen Levee			GPS Latitude/Longitude	
				Start	End
Item	Vegetation			38.698496°	38.687575°
				-121.674129°	-121.673738°
DWR ID	DWR_ST0011_03_s_2017_4				
Comment Code					
V1 : Control annual grass and weeds on the levee slopes and easements.					
Inspector Comment

Tall grass on landside levee slope, blocking visibility. Spring 2017.

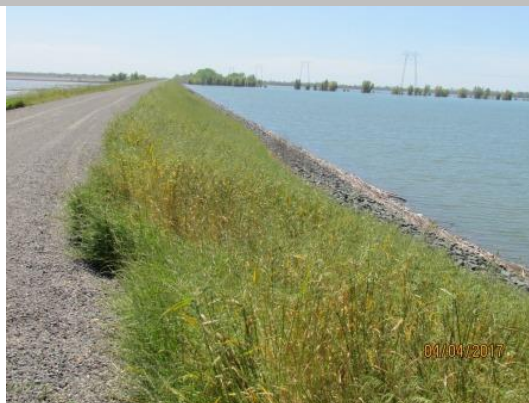
Photo 1 of 1 : SP_2017_ST0011_293_2_20170413_00010.jpg

LM Start	1.13	Rating **	U	Issue No.	2
LM End	1.48	Issue Type +	Ma	Location *	LS
Category	Earthen Levee			GPS Latitude/Longitude	
				Start	End
Item	Vegetation			38.682264 °	38.677228 °
				-121.672897 °	-121.672800 °
DWR ID	DWR_ST0011_03_s_2017_2				
Comment Code					
V1 : Control annual grass and weeds on the levee slopes and easements.					
Inspector Comment

Tall grass on landside levee slope, blocking visibility. Spring 2017.

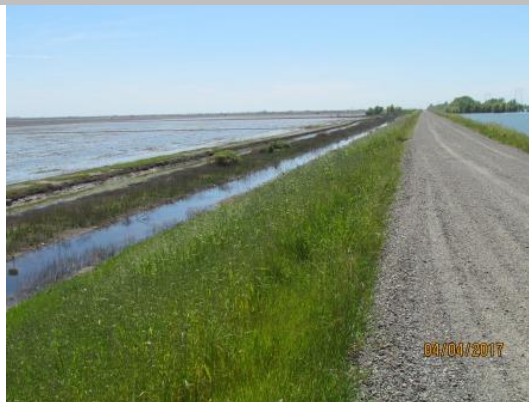
Photo 1 of 1 : SP_2017_ST0011_293_3_20170413_00009.jpg

LM Start	1.13	Rating **	U	Issue No.	3
LM End	1.48	Issue Type +	Ma	Location *	WS
Category	Earthen Levee			GPS Latitude/Longitude	
				Start	End
Item	Vegetation			38.682264 °	38.677228 °
				-121.672897 °	-121.672800 °
DWR ID	DWR_ST0011_03_s_2017_3				
Comment Code					
V1 : Control annual grass and weeds on the levee slopes and easements.					
Inspector Comment

Tall grass on waterside levee slope, blocking visibility. Spring 2017.

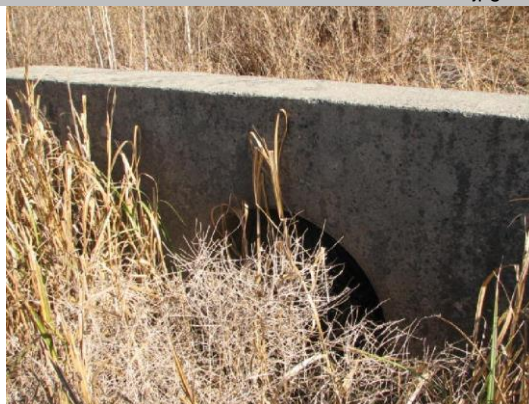
Photo 1 of 3 : UCIP_SP_2017_44826_60517.jpg

LM Start	0.60	Rating **	A/W	Issue No.	34
LM End	0.60	Issue Type +	Ma	Location *	CR
Category	Supplemental			GPS Latitude/Longitude	
				Start	End
Item	DWR UCIP LMA Responsibility			38.565704 °	38.565704 °
				-121.638650 °	-121.638650 °
DWR ID					
Comment Code					
Inspector Comment					
FS_ID:44826 DS_ID:528 EP_NO: 10304 Repair Type: No Action Needed Crossing Status: Found UCIP Comments: FIELD_STRUCT_DESC: 30-inch CM pipe through levee 22.0 feet below crown. Flap gate on waterward end. (ABO No. 10304 - Southern Pacific Transportation Company). O&M manual 120, Revision Year 2010. FS Date: 4/28/2015 2:58:55 PM

Landside view: concrete headwall.

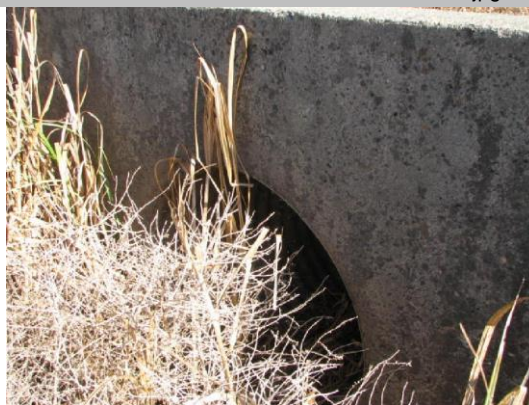
Photo 2 of 3 : UCIP_SP_2017_44826_60516.jpg

Landside view: closer look at the headwall.

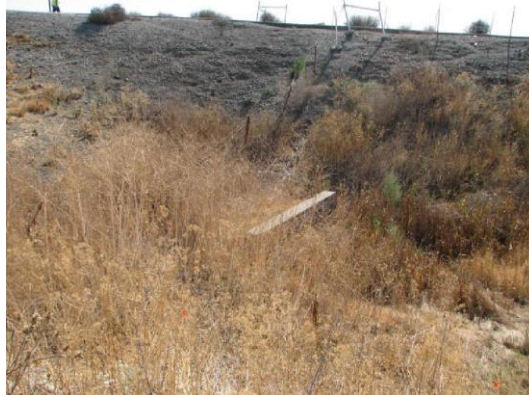
Photo 3 of 3 : UCIP_SP_2017_44826_60520.jpg

Landside view: overview

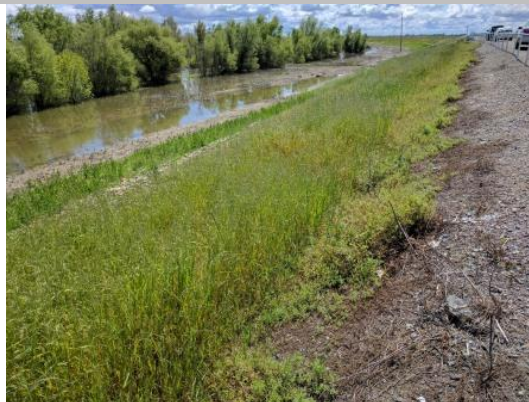
Photo 1 of 1 : SP_2017_ST0011_294_33_20170419_00025.jpg

LM Start	0.84	Rating **	M	Issue No.	33
LM End	3.61	Issue Type +	Ma	Location *	WS
Category	Earthen Levee			GPS Latitude/Longitude	
				Start	End
Item	Vegetation			38.562202 °	38.523700 °
				-121.638269 °	-121.631465 °
DWR ID	DWR_ST0011_04_s_2017_33				
Comment Code					
V1 : Control annual grass and weeds on the levee slopes and easements.					
Inspector Comment

View of tall grass on waterside levee slope, blocking visibility. Spring 2017.

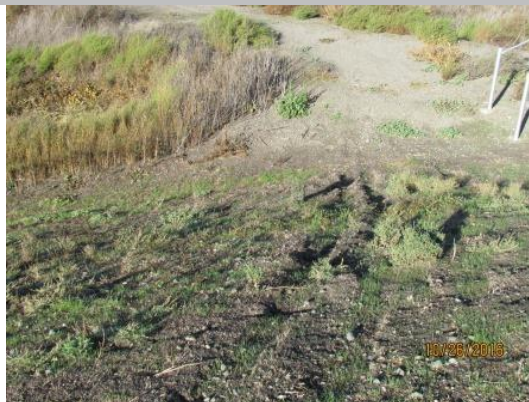
Photo 1 of 1 : SP_2017_ST0011_294_16_20170320_00009.jpg

LM Start	1.00	Rating **	M	Issue No.	16
LM End	1.00	Issue Type +	Ma	Location *	LS
Category	Earthen Levee			GPS Latitude/Longitude	
				Start	End
Item	Slope Stability			38.559998 °	38.559998 °
				-121.638014 °	-121.638014 °
DWR ID	DWR_ST0011_04_f_2016_16				
Comment Code					
S3 : Repair the levee slope damaged by vehicle traffic and prevent access where possible.					
Inspector Comment

Slope was damaged by vehicle. Fall 2016.

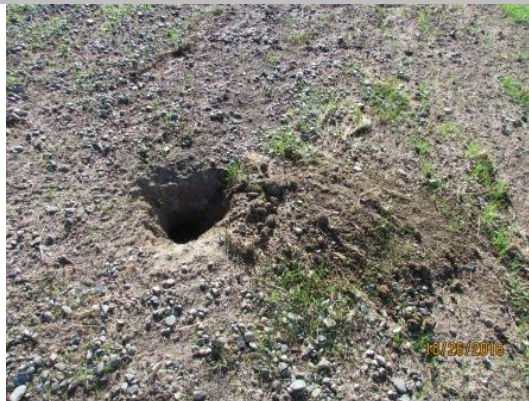
Photo 1 of 1 : SP_2017_ST0011_294_21_20170320_00015.jpg

LM Start	1.44	Rating **	A/W	Issue No.	21
LM End	1.44	Issue Type +	Ma	Location *	LS
Category	Earthen Levee			GPS Latitude/Longitude	
				Start	End
Item	Animal Control			38.554636 °	38.554636 °
				-121.633619 °	-121.633619 °
DWR ID	DWR_ST0011_04_f_2016_21				
Comment Code					
A3 : No rodents visible, but rodent burrows visible; need to backfill and compact or grout burrows.					
Inspector Comment					
Animal burrow at LS toe.

View of an animal burrow. Fall 2016.

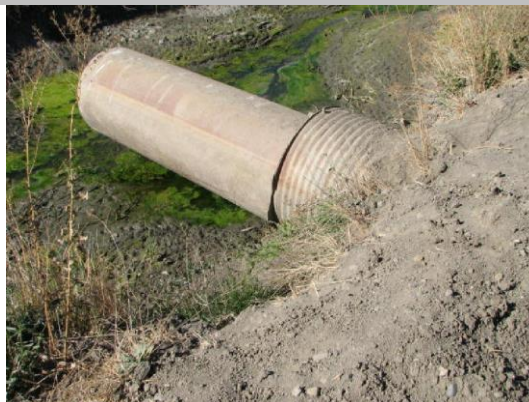
Photo 1 of 3 : UCIP_SP_2017_44822_24980.jpg

LM Start	2.10	Rating **	A/W	Issue No.	41
LM End	2.10	Issue Type +	Ma	Location *	LS
Category	Supplemental			GPS Latitude/Longitude	
				Start	End
Item	DWR UCIP LMA Responsibility			38.545646 °	38.545646 °
				-121.631172 °	-121.631172 °
DWR ID					
Comment Code					
Inspector Comment					
FS_ID:44822 DS_ID:17736 EP_NO: 10306 Repair Type: No Action Needed Crossing Status: Found UCIP Comments: Farmer cleans this screw gate every year FIELD_STRUCT_DESC: A 42-inch steel pipe inside a 48-inch CM drainpipe through the levee, 21.5 ft. below the crown and a flap gate on the waterside of the levee; w/ 2 cut-off walls, 1 headwall, and 1 saddle and apron. ABO No. 10306. O&M manual 119, Revision Year 2010 FS Date: 4/28/2015 2:57:49 PM

Landside view: 42-inch steel pipe inside a 48-inch CMP

FS_ID:44822
DS_ID:17736
EP_NO: 10306
Repair Type: No Action Needed
Crossing Status: Found
UCIP Comments: Farmer cleans this screw gate every year
FIELD_STRUCT_DESC: A 42-inch steel pipe inside a 48-inch CM drainpipe through the levee, 21.5 ft. below the crown and a flap gate on the waterside of the levee; w/ 2 cut-off walls, 1 headwall, and 1 saddle and apron.
ABO No. 10306.
O&M manual 119, Revision Year 2010
FS Date: 4/28/2015 2:57:49 PM

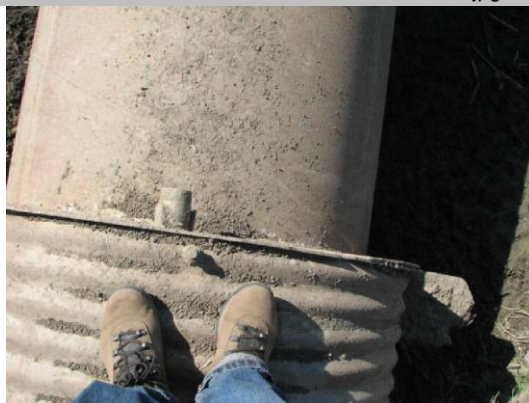
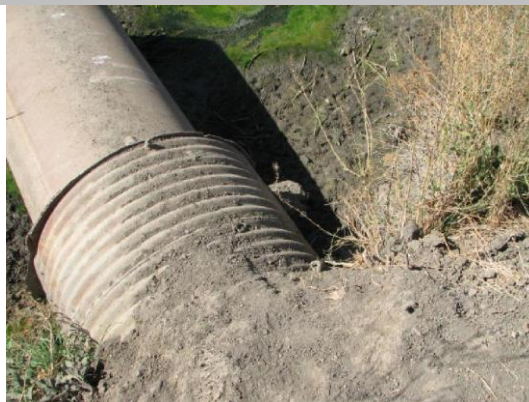
Landside view: closer look at 42-inch steel pipe and 48-inch CMP

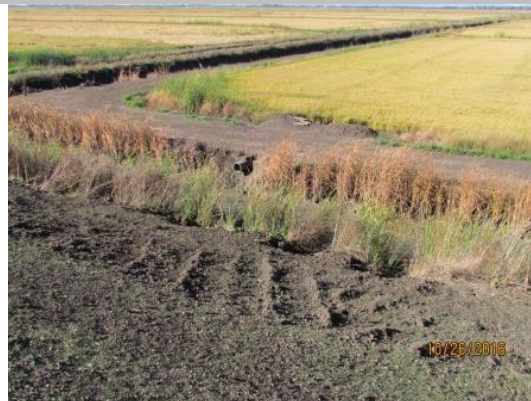
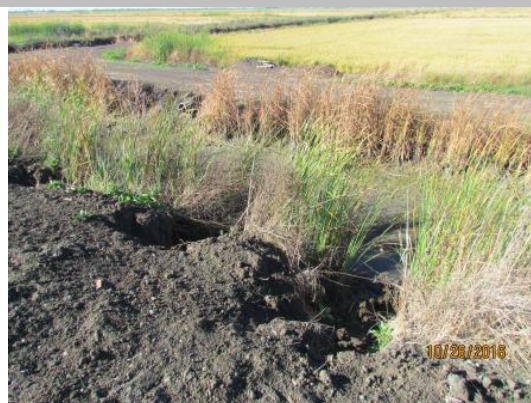
LM Start	2.11	Rating **	M	Issue No.	19
LM End	2.11	Issue Type +	Ma	Location *	LS
Category	Earthen Levee			GPS Latitude/Longitude	
				Start	End
Item	Erosion / Bank Caving			38.545430 °	38.545430 °
				-121.631211 °	-121.631211 °
DWR ID	DWR_ST0011_04_f_2016_19				
Comment Code					
E2 : Schedule repair of erosion site prior to the next inspection.					
Inspector Comment					
It appears that the ditch is beginning to erode the landside levee toe.

View of erosion on landside levee slope. Fall 2016.

Closer view of erosion. Fall 2016.

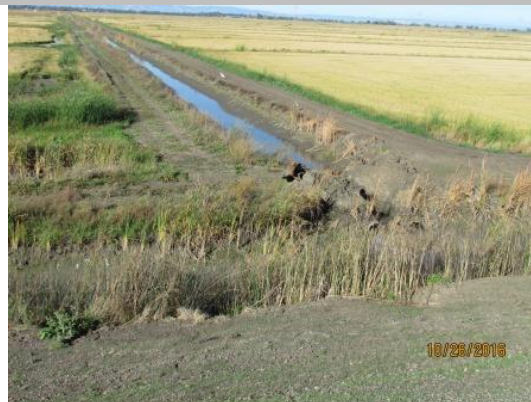
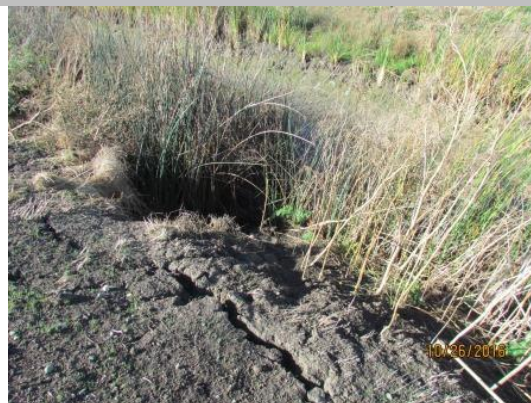
LM Start	2.14	Rating **	M	Issue No.	17
LM End	2.14	Issue Type +	Ma	Location *	LS
Category	Earthen Levee			GPS Latitude/Longitude	
				Start	End
Item	Erosion / Bank Caving			38.545022 °	38.545022 °
				-121.631209 °	-121.631209 °
DWR ID	DWR_ST0011_04_f_2016_17				
Comment Code					
E2 : Schedule repair of erosion site prior to the next inspection.					
Inspector Comment					
It appears that the ditch is beginning to erode the landside levee toe.

View of erosion at landside levee toe. Fall 2016.

Closer view of erosion. Fall 2016.
